# Making Power Generation Make Sense by Removing Siloxanes from Digester Gas

*P.M. Tower and J.V. Wetzel, Applied Filter Technology, Inc., Snohomish, WA, USA*

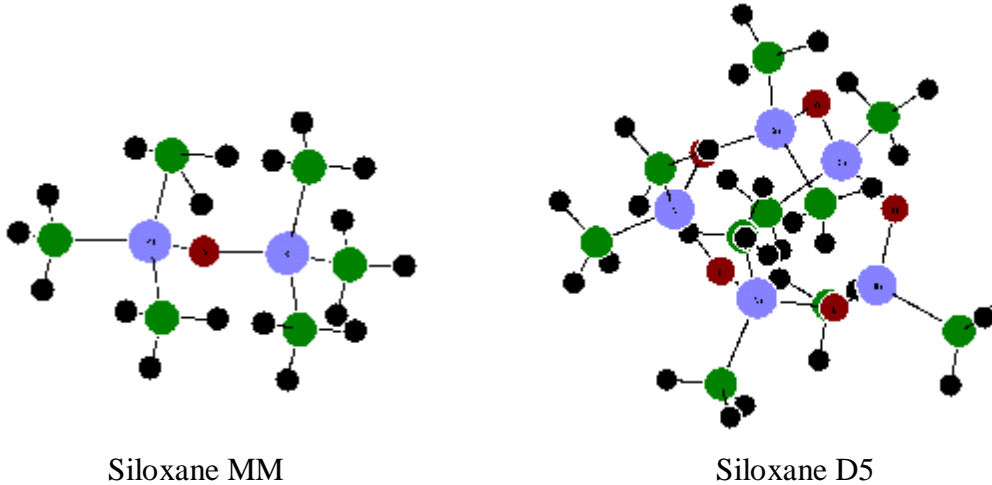
digester gas. These are hexamethyldisiloxane, or MM, or L2, octamethylcyclotetrasiloxane, or D4, and decamethylcyclopentasiloxane, or D5. MM is what is called a linear molecule, whereas D4 and D5 are cyclical molecules. D4 and D5 are sometimes called “cyclomethicones.” Below are pictures of the MM and D5 structures.

Hexamethyldisiloxane, is sometimes called MM nor L2. Its molecular formula is  $\text{Si}_2(\text{CH}_3)_6\text{O}$ . MM is very difficult to remove from digester gas because of its high volatility. Decamethylcyclopentasiloxane, or D5, as it is sometimes called is very prevalent in digester gas. Its molecular formula is  $\text{Si}_5(\text{CH}_3)_{10}\text{O}_5$ . D5 is easier to remove from digester gas because of its lower volatility.

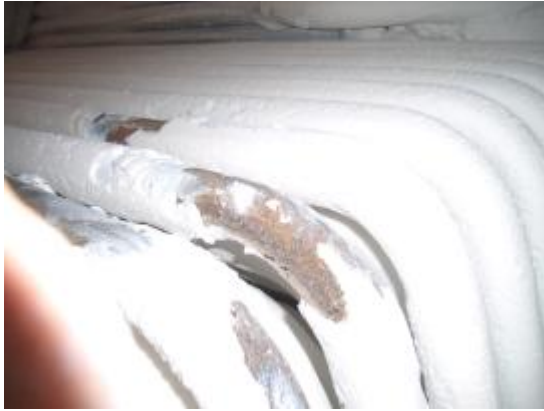
Silicon dioxide deposits on boiler tubes

Obviously, this boiler was not performing very well when the silicon dioxide built up this thick layer of deposits. Because there can be other minerals in digester gas, the silicon dioxide deposit can also be grayish, tan, or brown in color. To the right is a picture of a piston crown in an IC engine that suffered severe silicon dioxide and silicate damage. This engine has to be completely re-built at a cost of around \$90,000.

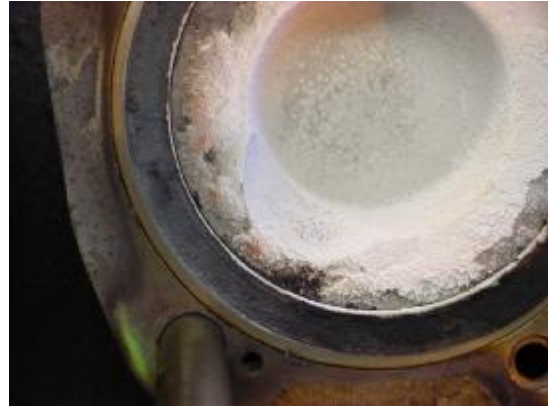
Silicon dioxide deposits on piston crown.

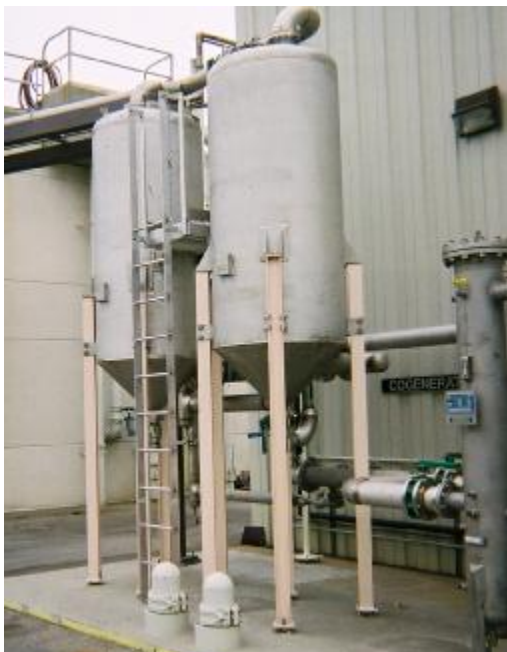
Santa Cruz Siloxane Removal System

Shortly after the cogeneration engine was placed into service, it required head and valve service. The engine was operated for about a year or so before it was decided to explore the cause of the engine damage. Siloxanes were detected in the digester gas at a concentration of between 1.5 and 3.0 ppmv. Plant personnel then began to determine what type of treatment could be used, and contacted AFT. AFT designed a SAG™ treatment system for the removal of siloxanes. This is a passive system consisting of two vessels operated in series, each vessel containing a special media selected for the Santa Cruz digester gas characteristics. Key decision factors were maintenance cost and downtime. The system was procured and installed in early of 2003.

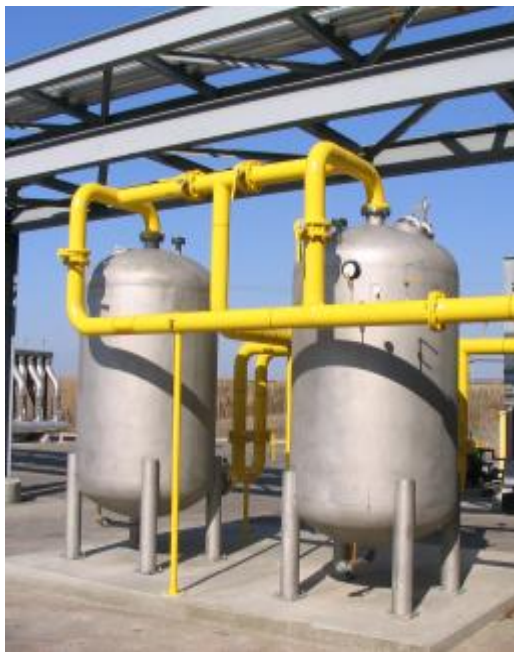
Stockton Siloxane Removal System

The City of Stockton, CA had been operating naturally aspirated Waukesha engines when maintenance problems began to occur in 2001. AFT was contacted to design a siloxane removal system, which was subsequently installed in September of 2003. This system consists of two 60 inch diameter dish top and bottom vessels piped in series. The media is changed out of one vessel on approximately an annual basis. Stockton later changed to “lean burn” engines, and have operated these for about a year and a half. Thus, the operating experience on each type of engine is much less than the operating experience at Santa Cruz. Nonetheless, some cost savings are readily apparent.
